XMM-Newton CCF Release Note

XMM-CCF-REL-381

RGS Bad Pixels - advisory extended segments

April 27, 2021

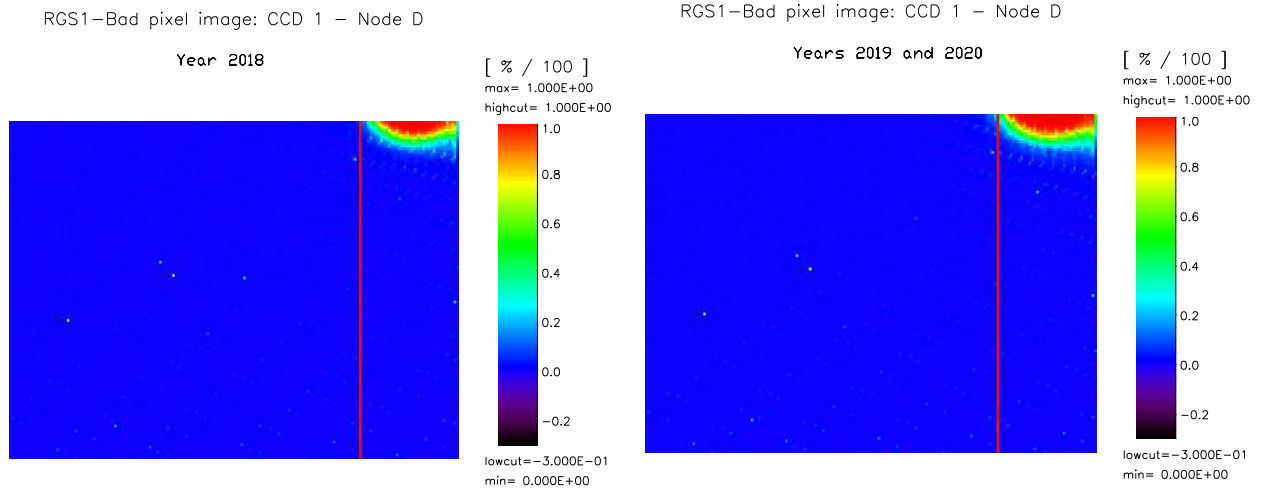
The two areas with higher offsets ("hot spots") on both upper part sides of CCD 1 in RGS1 have increased their size by 8 rows and 8 columns. These regions are now 48 px × 24 px.

The hot spot in the upper left corner of CCD1/RGS1 can be clearly seen in the offset maps produced from the diagnostic data collected along 2019 and 2020 (see Fig. 1). The effect is noticeable in both

Figure 1: Badpixel map for RGS1 - CCD 1 - node D. Left: Data corresponding to 2018. Right: Data averaged over year 2019 and 2020. The "hot spot" can be seen in the upper right corner in both images, increasing along both axes in the most recent data. The known hot column in $X_{CCF} = 38$ is also evident in both images.

nodes, but it is more easily seen in the images corresponding to node D since the hot column in $X_{CCF} = 38$ can be used as a reference marker for the spot boundary. Its increase in size with respect to the area detected in 2018 has an effect on the science data, even when the advisory hot stuff is taken into account during data processing. This effect can be noticed as a series of leaks or pixels misidentified as bad in the area below the patched corner in both nodes, as well as a larger number of columns affected.

These new affected pixels are flagged as advisory hot segments with this CCF release. The previous two regions of 40 px × 16 px (one at each readout node) remain flagged as hot on board (uploaded hot segments).

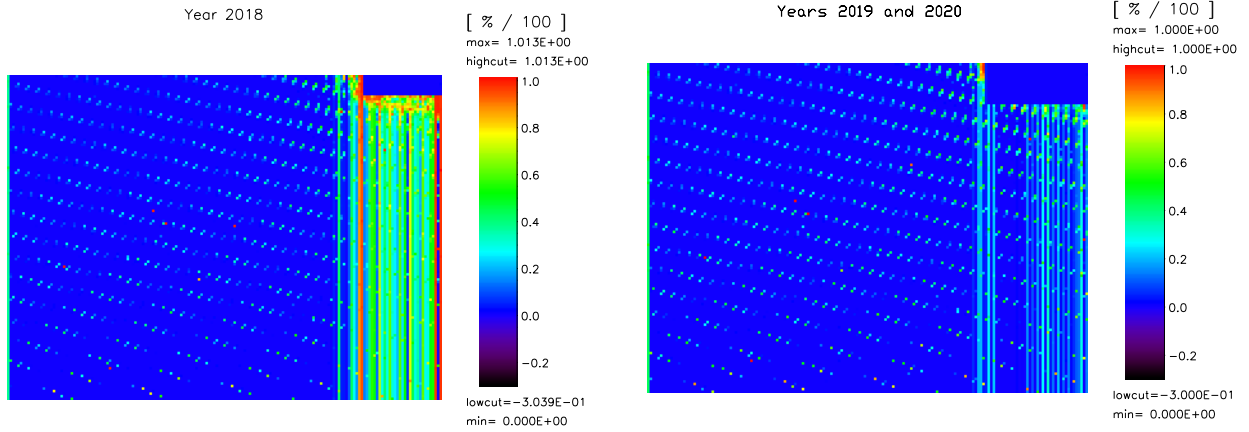
When running the bad pixel/column finding software (SAS task `rgsbadpixfind`) over the science data, the resulting bad pixel map clearly traces the expansion of the patches in the area immediately adjacent to it (see Fig. 2). It is clearly seen that, while the masking produced the desired effect of avoiding fake hot columns below the spot, there are now some new hot pixels to the right of the spot and below it giving rise to some columns being misidentified as hot. The significantly lower number of hot columns seen in the right panel of Fig. 2 with respect to those in the left panel shows the success of the version 15 of the Hot Stuff table (CCF RGS_BADPIX_0038, see XMM-CCF-REL-370). However, we still get a number of hot columns below and adjacent to the spot when we should be obtaining none. This is due to an expansion of the bad area. This evolution of the hot spots, growing slowly both in vertical as in horizontal direction, is the reason for extending now this spot further 8 columns to the right and 8 rows to the bottom, and so masking fully the hot spot area.

Figure 2: RGS1 - CCD1 - node D bad pixel map obtained from the science data. Left: Data obtained along 2018 with the Hot Pixel Table v14 on board, (CCF RGS_BADPIX_0035, see XMM-CCF-REL-347) . Right: Data obtained along 2019 and 2020 with the Hot Pixel Table v15 uploaded on board, (CCF RGS_BADPIX_0038, see XMM-CCF-REL-370).

As of the date of validity of this CCF, the masking of the upper left corner of CCD1 of RGS1 will be extended to cover an area of 48 px × 24 px when the `rgsproc` keyword `withadvisory` is set to `no`.
